DEPARTMENT OF TRANSPORTATION

Quality Assurance and Source Inspection

Contract #: 04-0120F4Cty: SF/ALA Rte: 80 PM: 13.2/13.9File #: 69.28**WELDING INSPECTION REPORT****Resident Engineer:**Pursell, Gary**Address:** 333 Burma Road**City:** Oakland, CA 94607**Report No:** WIR-013421**Date Inspected:** 25-Apr-2010**Project Name:** SAS Superstructure**OSM Arrival Time:** 700**Prime Contractor:** American Bridge/Fluor Enterprises, a JV**OSM Departure Time:** 1900**Contractor:** Zhenhua Port Machinery Company, Ltd (ZPMC), Changxing Island **Location:** Shanghai, China**CWI Name:** Li Yang**CWI Present:** Yes No**Inspected CWI report:** Yes No N/A**Rod Oven in Use:** Yes No N/A**Electrode to specification:** Yes No N/A**Weld Procedures Followed:** Yes No N/A**Qualified Welders:** Yes No N/A**Verified Joint Fit-up:** Yes No N/A**Approved Drawings:** Yes No N/A**Approved WPS:** Yes No N/A**Delayed / Cancelled:** Yes No N/A**Bridge No:** 34-0006**Component:** OBG**Summary of Items Observed:**

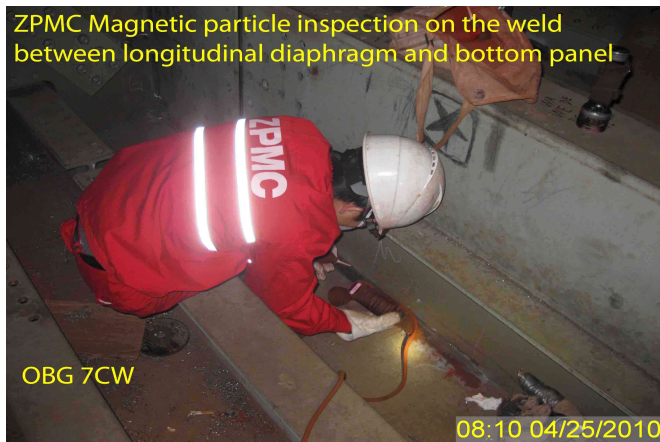
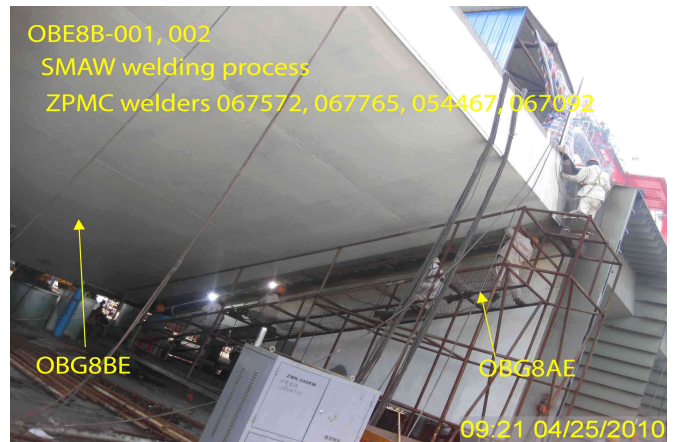
OBG SEGMENT 7CW-7DW

This Quality Assurance (QA) Inspector observed ZPMC QA Inspector performing magnetic particle inspection on the weld between longitudinal diaphragm and bottom panel (counter weight side). See attached photo.
